**International Road Tunnel Fire Detection  
Research Project – Phase II**

**Task 4: Field Fire Tests on Performance of Fire Detection  
Systems in an Operating Road Tunnel in Montreal**

National Research Council of Canada

© July 2008 Fire Protection Research Foundation

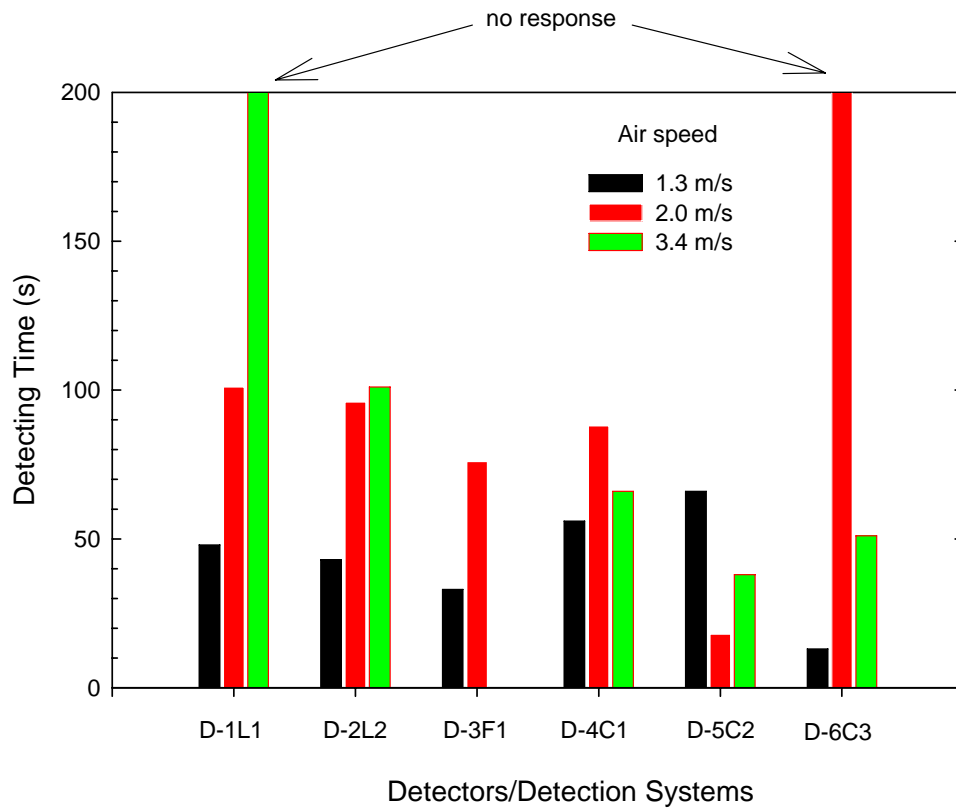
The response times of fire detectors/detection systems to the fire located underneath a vehicle for tests with three air velocities are summarized in Figure 7.14. Generally, the challenge for the detectors increased under the longitudinal airflow conditions.

The response times of the three VID systems to the fire could be delayed or shortened under airflow conditions, as the flames behind the obstacle were unsteady. The response time of the flame/smoke VID system D-4C1 was 56 s at 1.3 m/s and increased to 88 s at 2 m/s and then decreased to 66 s at 2.4 m/s.

The flame/smoke VID system D-5C2 detected the fire with response times of 66 s at 1.3 m/s, 18 s at 2 m/s and 36 s at 2.4 m/s.

The flame VID system D-6C3 did not respond to the fire in the test with an airflow speed of 2 m/s, but detected the fire at 13 s at 1.3 m/s and 51 s at 2.4 m/s.

Figure 7.14. Response times of fire detectors/detection systems to a 0.36 m<sup>2</sup> fire located underneath a vehicle at three air velocities in the tunnel

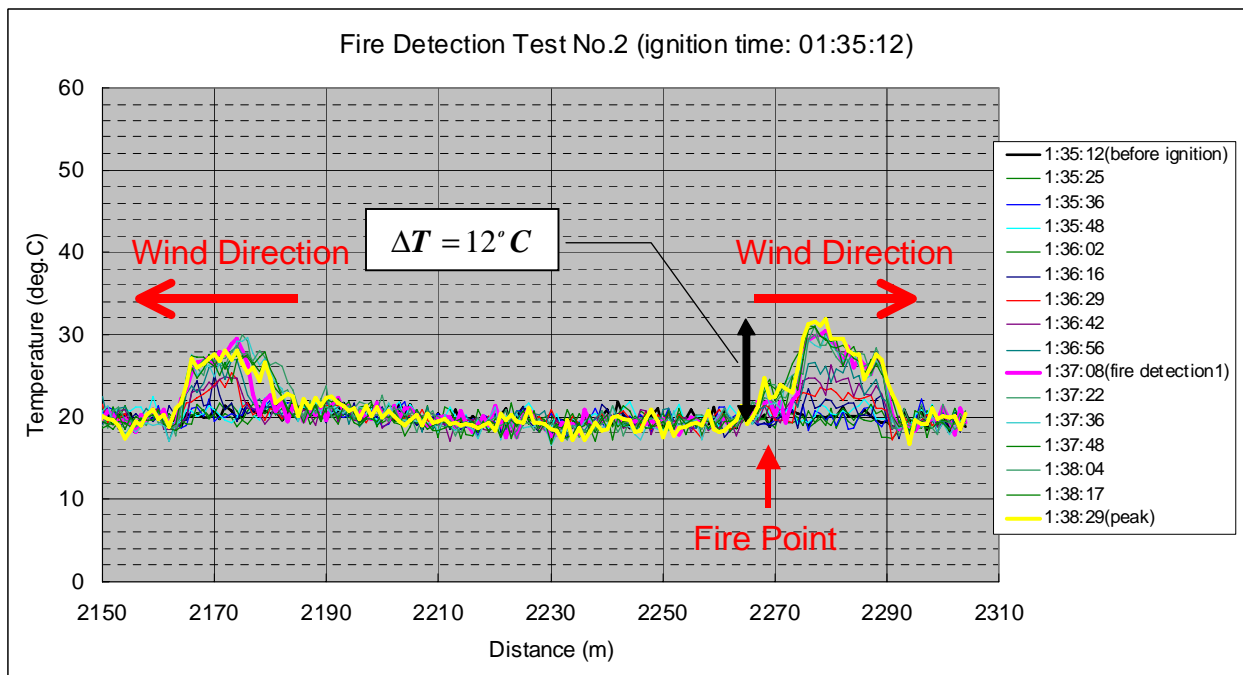
Figure 7.15. Temperatures along sensing cable of linear heat detection system D-1L1 in Test F-2

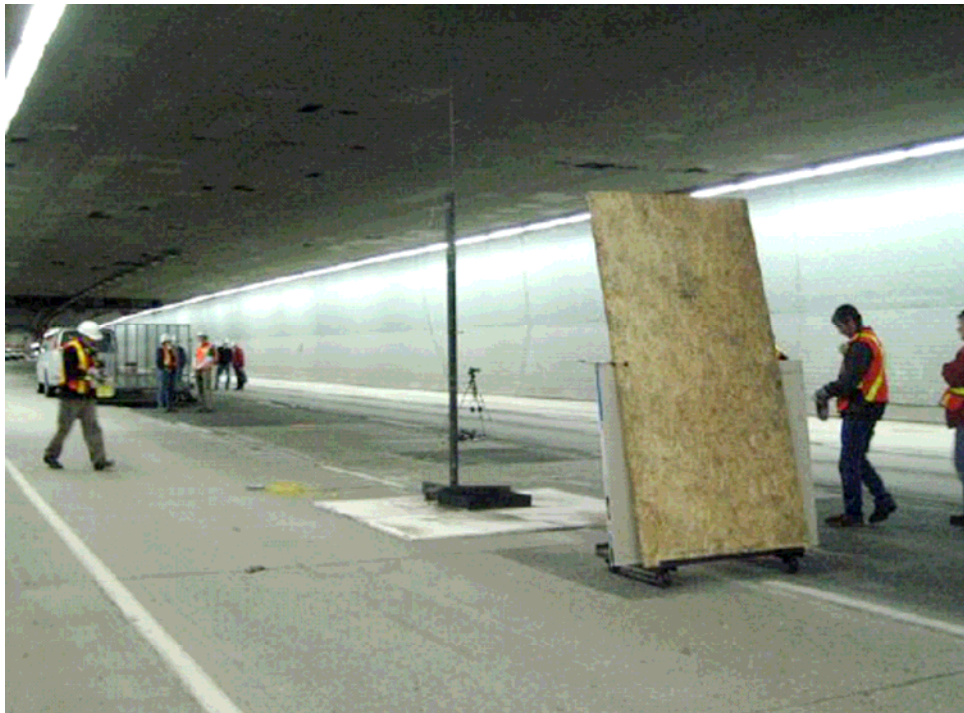
Two full-scale tests with a gasoline pool fire located behind a simulated vehicle (Tests F-6 and F-8) were conducted in the Viger Tunnel. The fire scenario was setup with a 0.36 m<sup>2</sup> gasoline pan fire located behind a large plate. The plate, simulating the front portion of a large van, was 1.2 m wide by 2.4 m high. It was placed 0.3 m above the tunnel floor and 3.5 m in front of the pool fire. It was located between the pool fire and the detectors mounted at the wall of the tunnel. The heat release rate of the fire was approximately 650 kW. The setup of the fire scenario is shown in Figure 7.16.

Figure 7.16. Photograph of the setup of a pool fire located behind a simulated vehicle

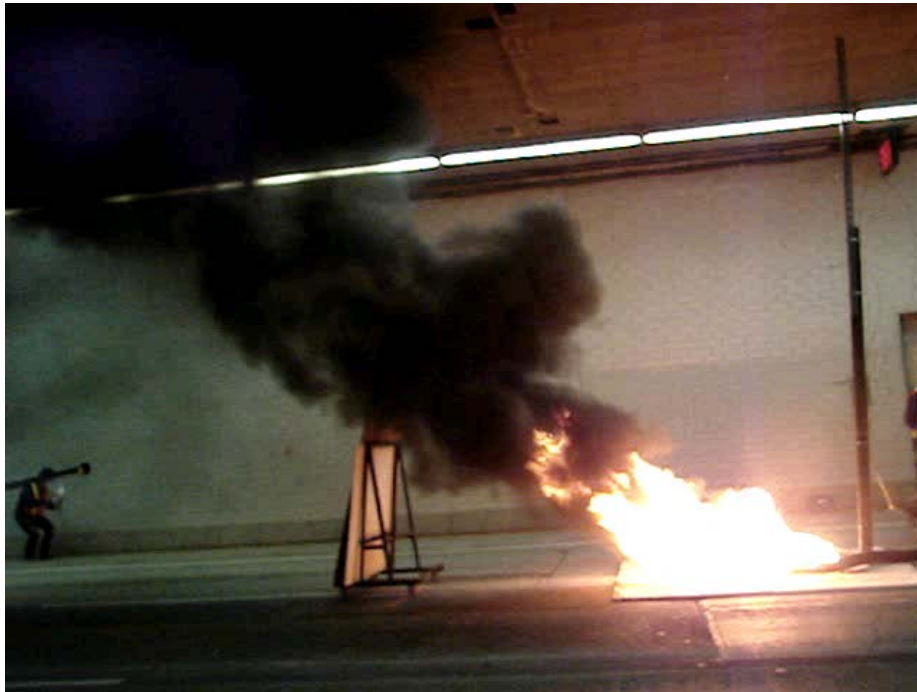
Figure 7.17. Photograph of a pool fire located behind a simulated vehicle in Viger Tunnel

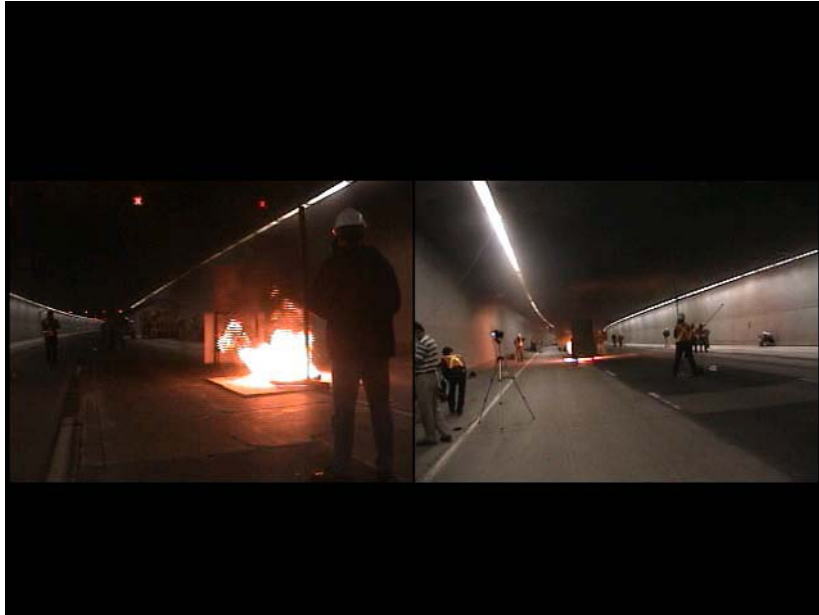
Figures 7.18 and 7.19 show photographs taken from the front and back of the fire setup, when the fire was located at 32 m and 60 m from the detectors. Although the fires behind the plate were large, the flames were only partially visible at the sides of the plate. However, the smoke produced from the fires was visible in the tunnel and was not affected by the obstacle. Figures 7.18 and 7.19 also show that the amount of flame visible at the two locations was comparable and were not affected by the change in fire location.

**Figure 7.18. Photographs of a pool fire located behind a simulated vehicle taken from front and back of the fire setup with the fire was located at 32 m from the detectors**

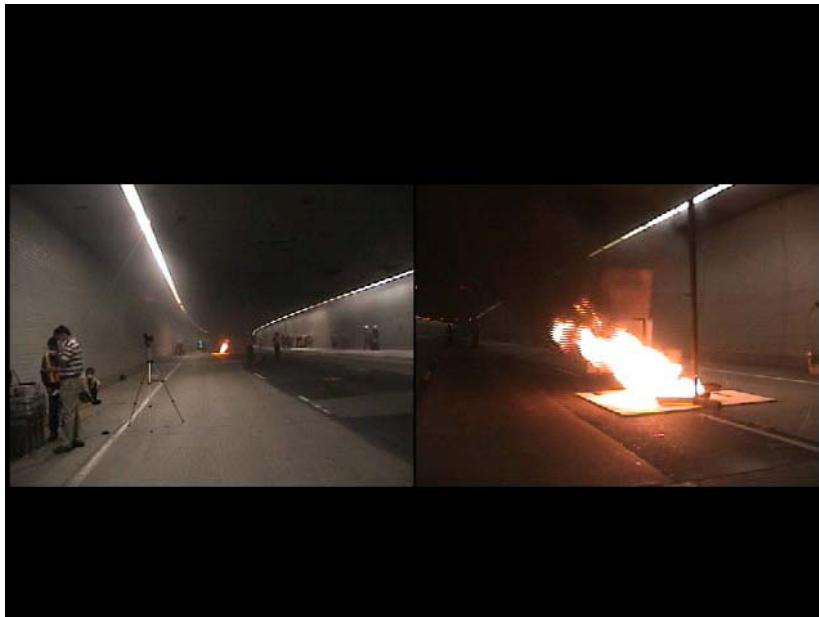
**Figure 7.19. Photographs of a pool fire located behind a simulated vehicle taken from front and back of the fire setup with the fire was located at 60 m from the detectors**

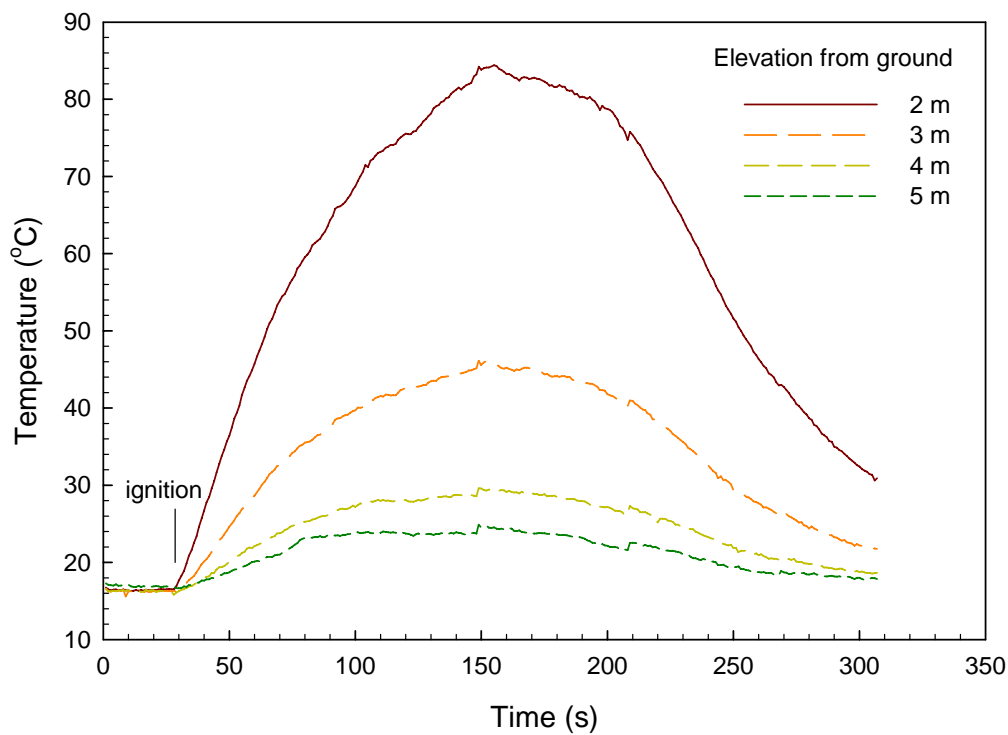
Figure 7.20 shows the temperatures measured in Test F-6. The temperatures were measured at thermocouple tree #1 near the fire source. The temperature near the tip of the fire plume was approximately 85°C. The temperature decreased with an increase in height. The maximum temperature increase near the ceiling of the tunnel was 7°C approximately 50 s after ignition (rate of rise of about 8.5°C/min).

Figure 7.20. Temperatures measured at Thermocouple #1 at fire location in Test F-6

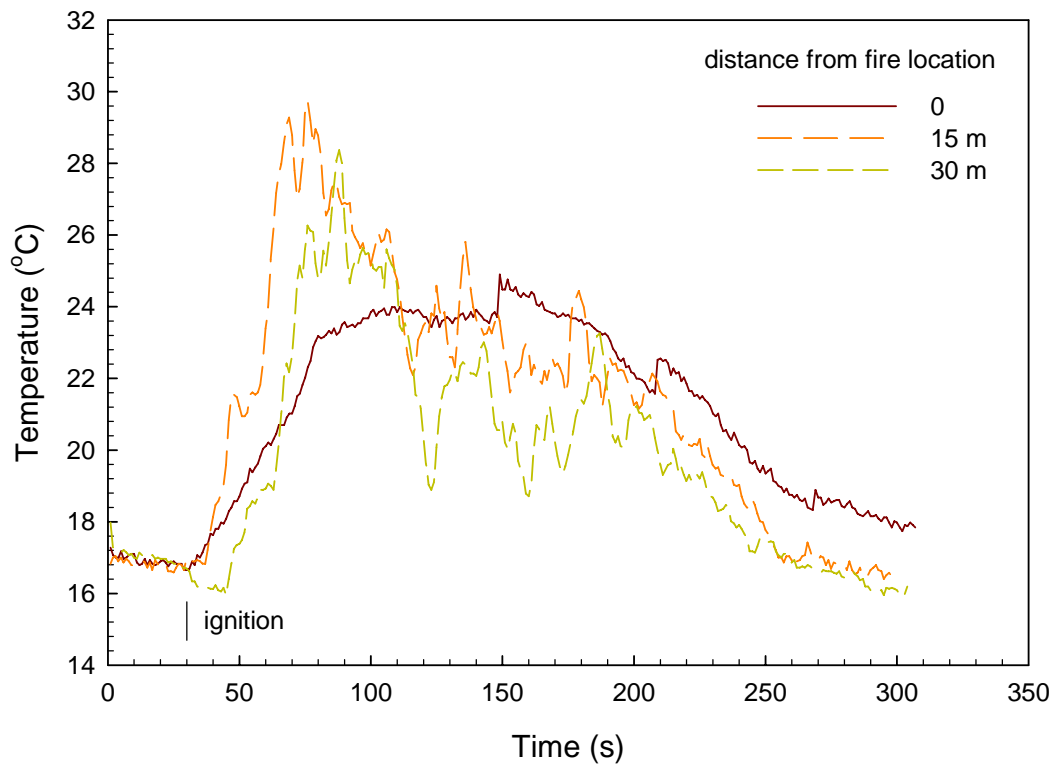
Figure 7.21 shows the ceiling temperature measured at three distances from the fire source in Test F-6. The temperatures measured 15 m and 30 m downstream of the fire were higher than that measured at the fire location (about 15.6 and 10.8°C/min at 15 and 30 m downstream of fire, respectively). The rate of temperature rise was also faster than that at the fire location. The ceiling temperature produced by the fire located behind the vehicle was higher than that produced by the fire located underneath the vehicle under the same airflow conditions.

**Figure 7.21. Ceiling temperatures at three distances from the fire in Test F-6**

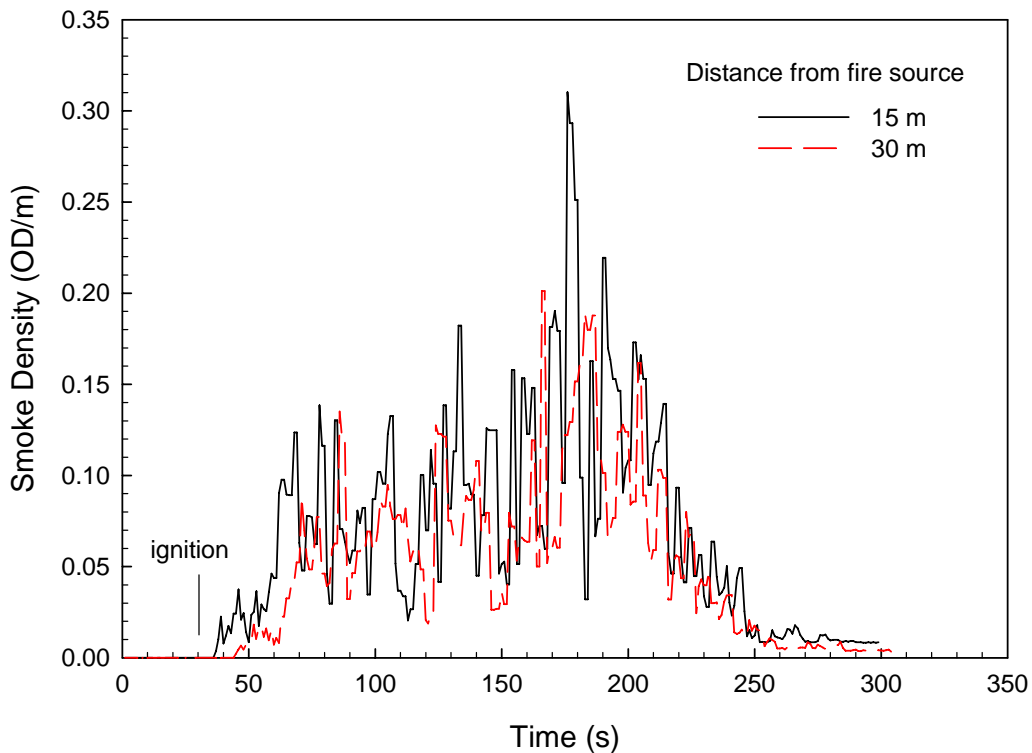
Figure 7.22 shows the smoke optical density measured 15 m and 30 m from the fire source in Test F-6. The smoke optical densities quickly increased. The smoke optical densities measured at the two locations were comparable. However, the smoke optical density 15 m from the fire was slightly higher than that at 30 m from the fire. The smoke optical density produced by the fire behind a vehicle was higher than that produced by the fire located underneath a vehicle under the same test conditions.

Figure 7.22. Ceiling smoke optical densities measured 15 m and 30 m from fire location in Test F-6

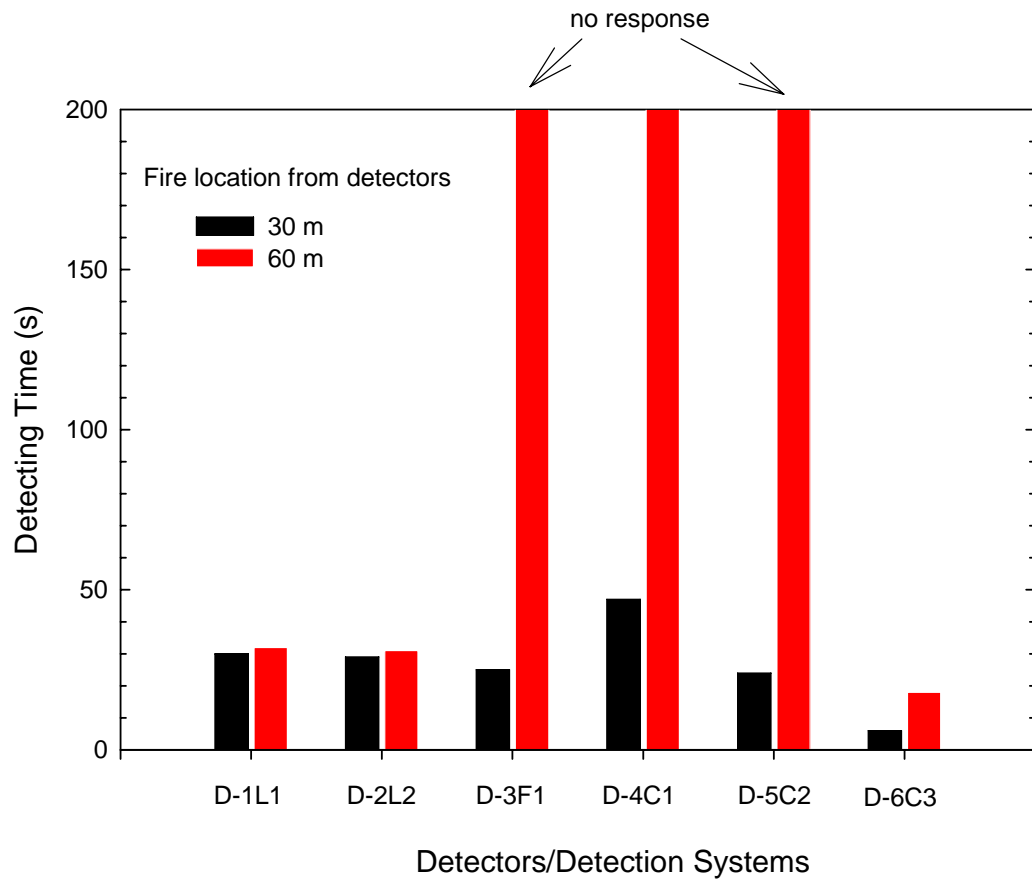
The flame VID system D-6C3 responded to the fires at 6 s when the fire was 32 m from the detector and 18 s when the fire was 60 m from the detector.

**Figure 7.23. Response times of fire detectors/detection systems to a 0.36 m<sup>2</sup> fire located behind the vehicle at two locations**
